## Annex 8 – Case study: first impressions of Camden, London

**Joan Oxley**

Building Research Establishment Ltd, UK

Summary of presentation in Athens, Greece, March 2004

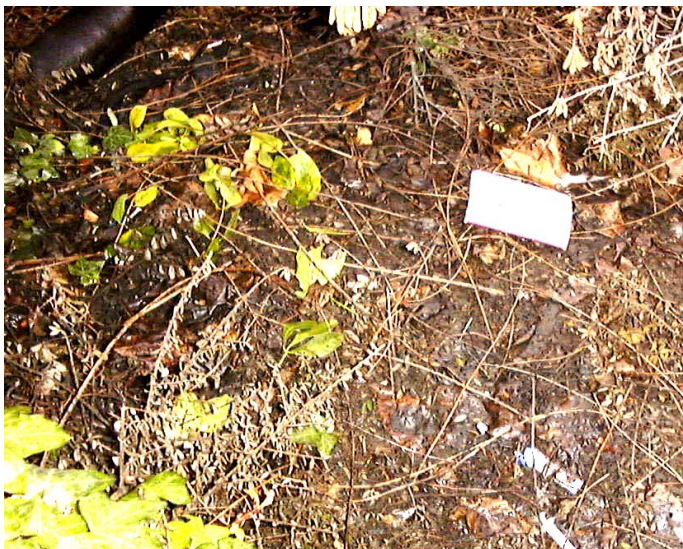
- Several problems highlighted - signs of a bush fire; human defecation; alcohol cans and bottles; drug use; bin area covered in human debris. Poor lighting on pedestrian approach between garden and building.
- Garden generally appeared to be well kept but possibly used on regular basis by undesirables to show this type of deterioration

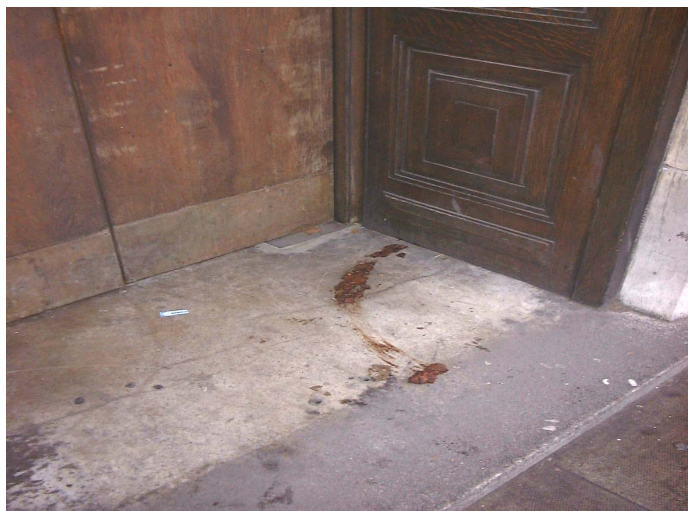
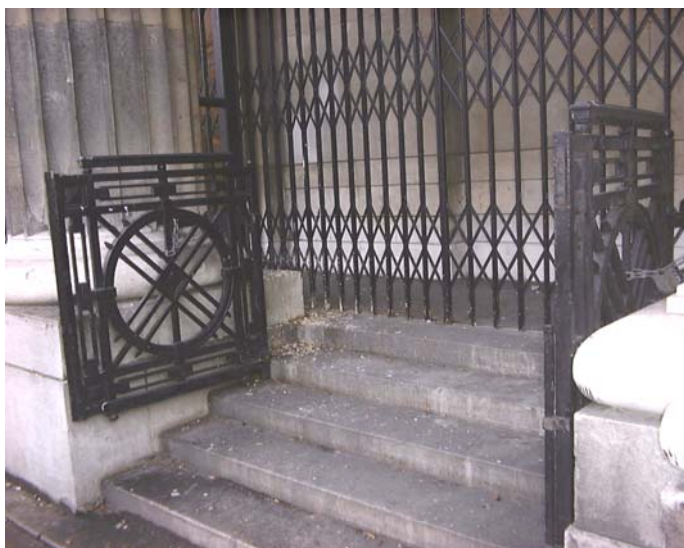
- One side of the same building faces the busy main road
- Has several flights of steps leading up to deep recesses
- Some steps have wooden doors fitted at the top (presumably closed and locked at night) but still evidence of misuse as shown in the photo below
- Beer cans etc also indicated area is used for seating for possibly 1 or more street drinkers, rough sleepers etc.

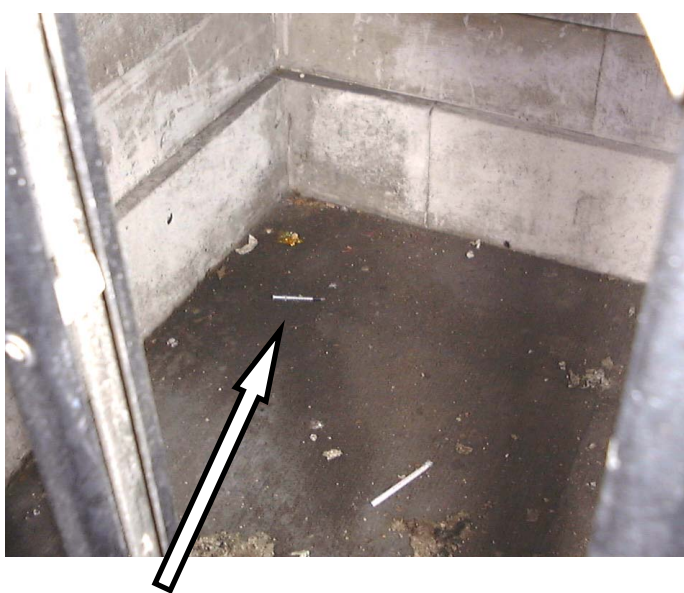
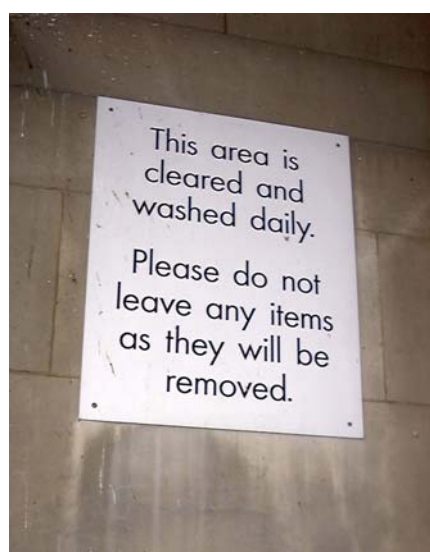
- Some steps have low level gates fitted in addition to locked grilles that still enable clear line of sight to the building and have been effective in reducing misuse
- Building was visited twice (2 days apart) – despite signage advising of daily cleaning rubbish that was there on day 1 was still there on day 2

A syringe was found directly below the cleaning signage

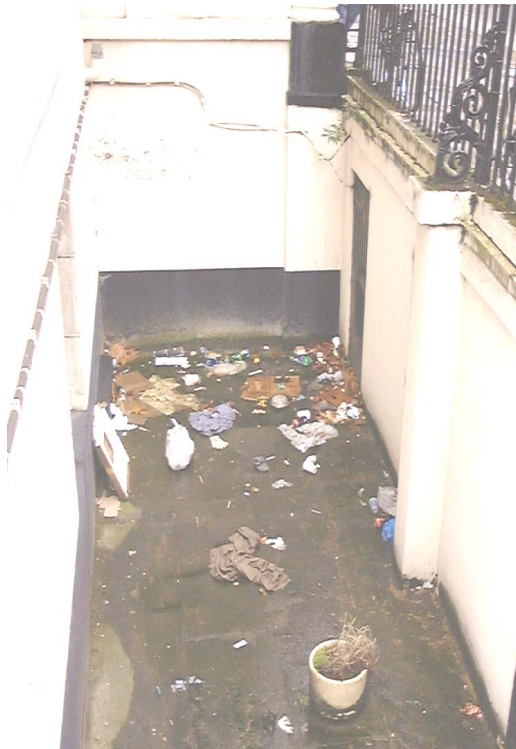
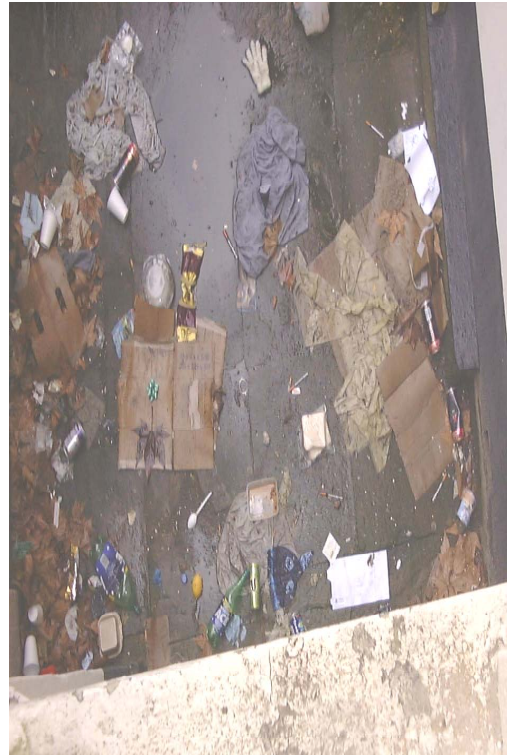
- The corner property on the minor road at the southern border of the map has a meeting room to the left of steps leading to main entrance with a recessed doorway
- Basement area pictured below can easily be viewed from steps – at time of photo there was a meeting taking place in the room above.

- 15–20 syringes, beer cans etc were easily visible. More syringes likely to be below the other rubbish
- Impact on staff, visitors etc.?
- When visited again 2 days later there had been no attempt to clear the debris
- This was by far the worst basement area found during the case study
- The adjoining basement area is occupied by a children's nursery – impact on parents, children and nursery as a business?

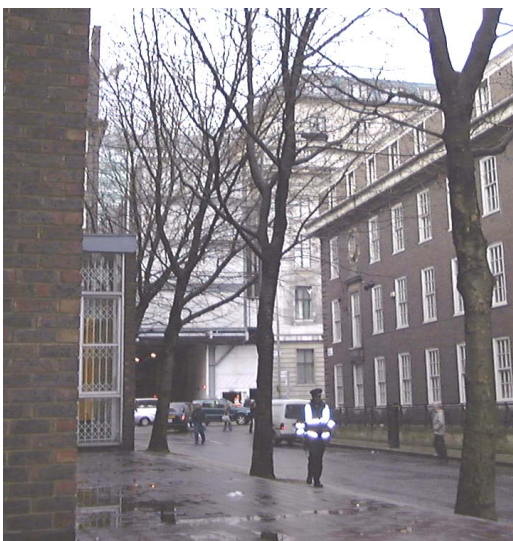
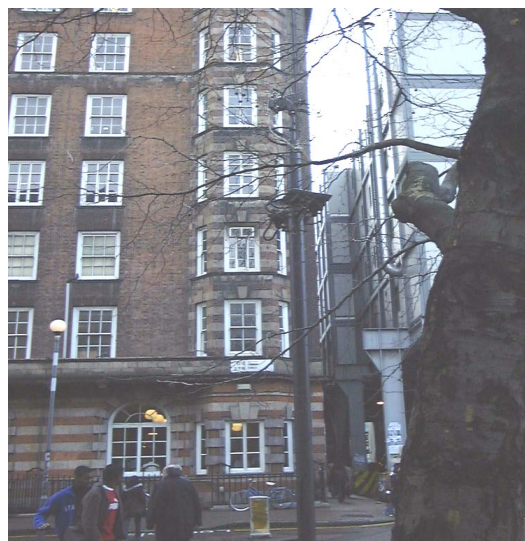
- Street lighting will be obscured by tree when in leaf
- Camera placed on a tree – fine in winter but when tree is in leaf camera will be ineffective

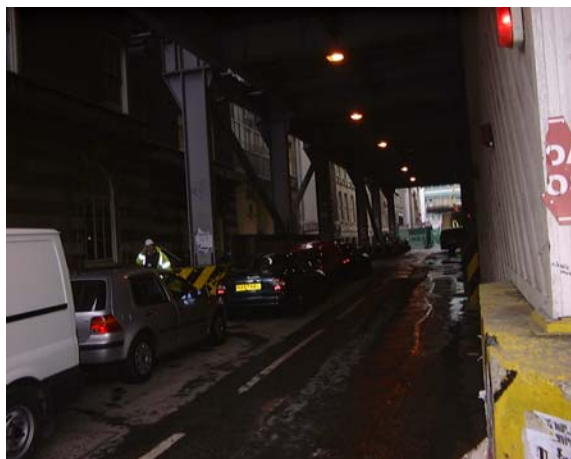
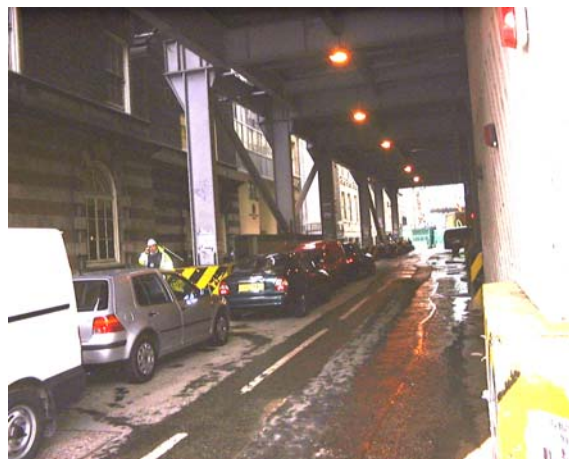
Actual light intensity

Light enhanced

- Major construction work, creating almost a tunnel effect; poor lighting even in daylight hours
- Construction worker pictured was on opposite pavement to the photographer showing how narrow the access is

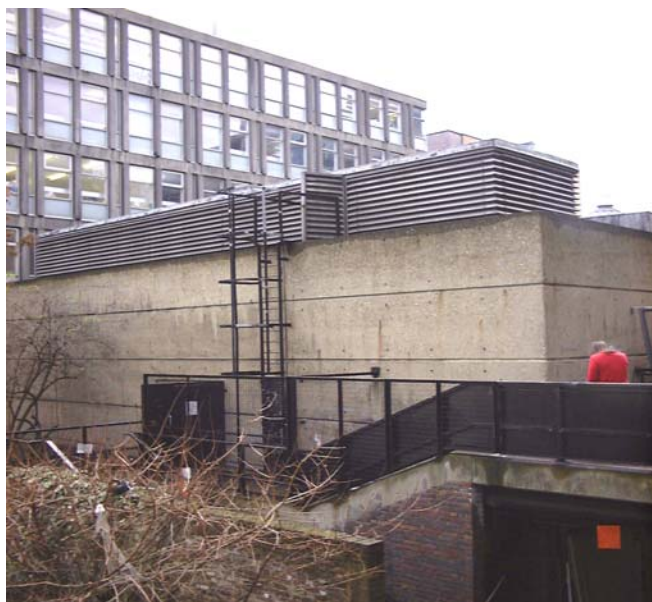
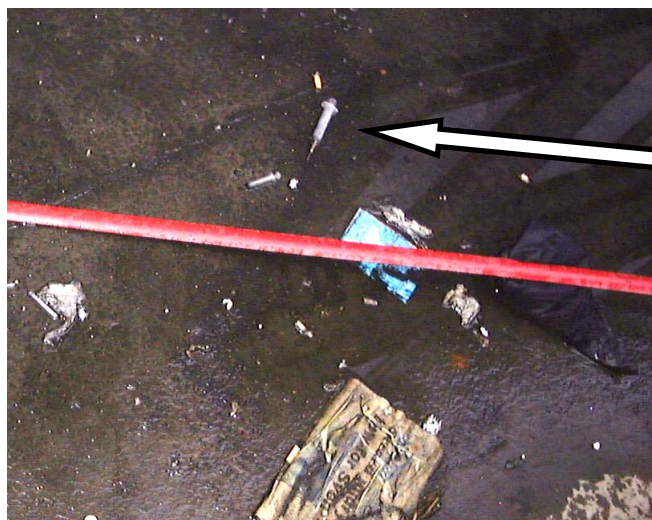
#### Building at far end of construction work

- Despite metal gate and keypad lock it is still easy to get onto the flat roof and gain access to adjoining building via any open/unlocked windows
- Natural surveillance of area onto roof likely to be poor at night

Light enhanced

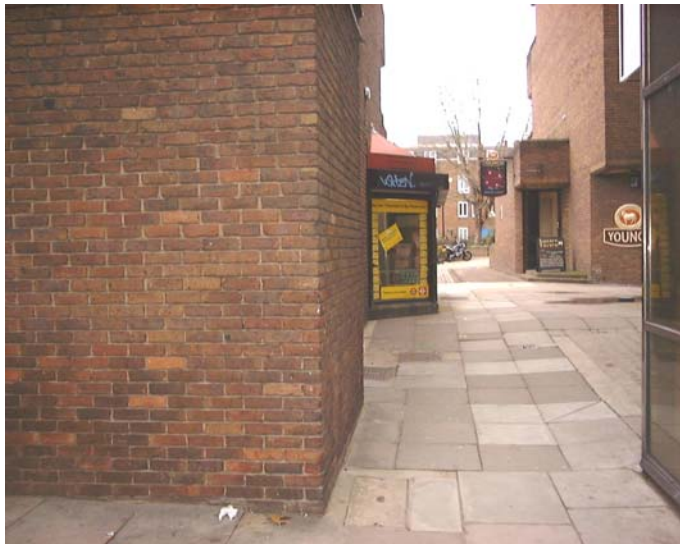
- This 'square' is primarily residential but incorporates a public house, hair-dressers and newsagents. Four access routes into the square.
- One pedestrian entrance to the square
- (Out of photo)
  - Some attempt at gating although gate is damaged and will not close
  - Fly tipping of domestic waste
  - Used as a toilet area
- Very poor lighting – only 1 light close to gate and none on pedestrian approach shown
- Natural surveillance poor as windows overlooking approach appear to be bathrooms

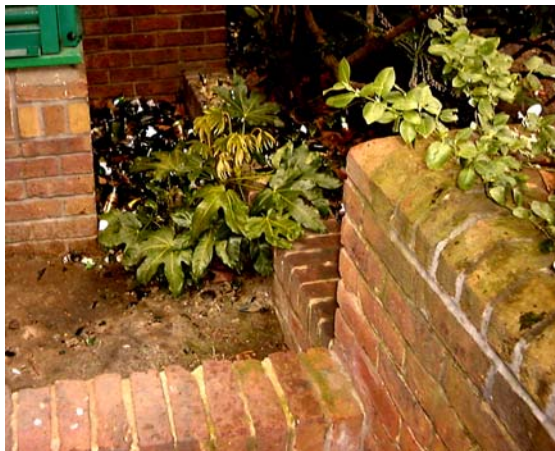
### Within the square

- Shutters of newsagents heavily graffitied.
- Planters outside hairdressers have broken glass placed there and in surrounding foliage indicating owner has experienced some problems.
- Walls surrounding planters are only approximately 0.75 metres high — glass is especially dangerous for children

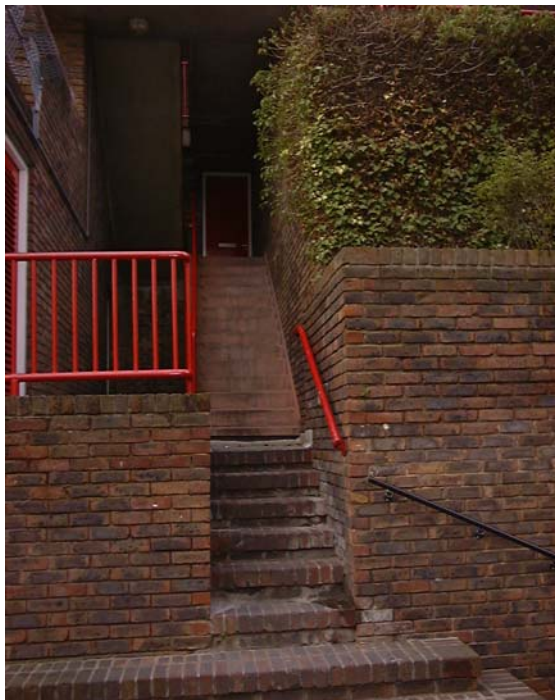
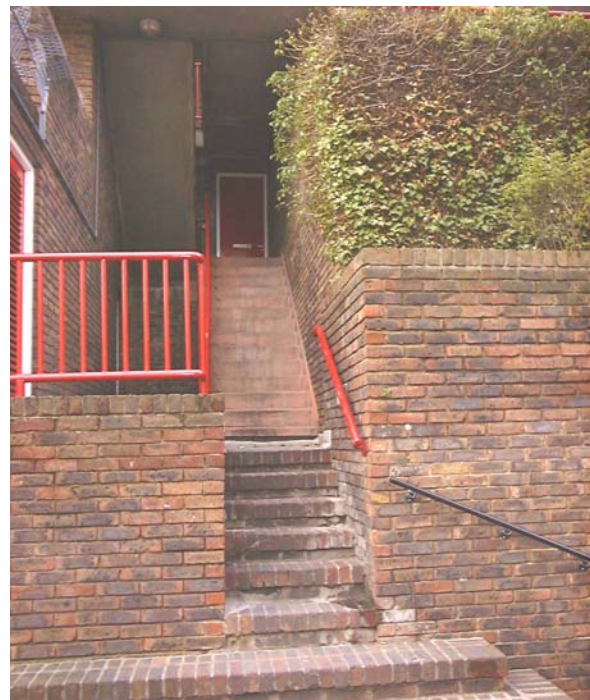
### Local housing estate – poorly lit entrances to some badly designed properties

Actual light intensity

Light enhanced

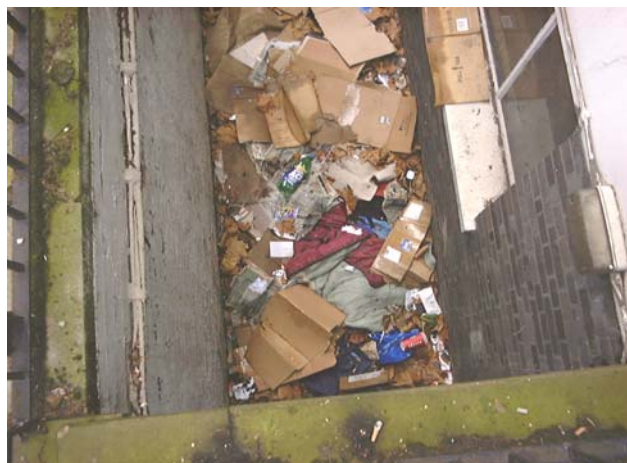
Camden has many properties with deep basements – many are well maintained with some used by restaurants as additional dining areas. Others are not so well maintained.

- Proliferation of rubbish in basement of property for sale
- 2 broken windows giving access to rough sleepers etc
- Potential fire hazard in dry weather
- Building condition poor, paint peeling off building, generally bringing down the area

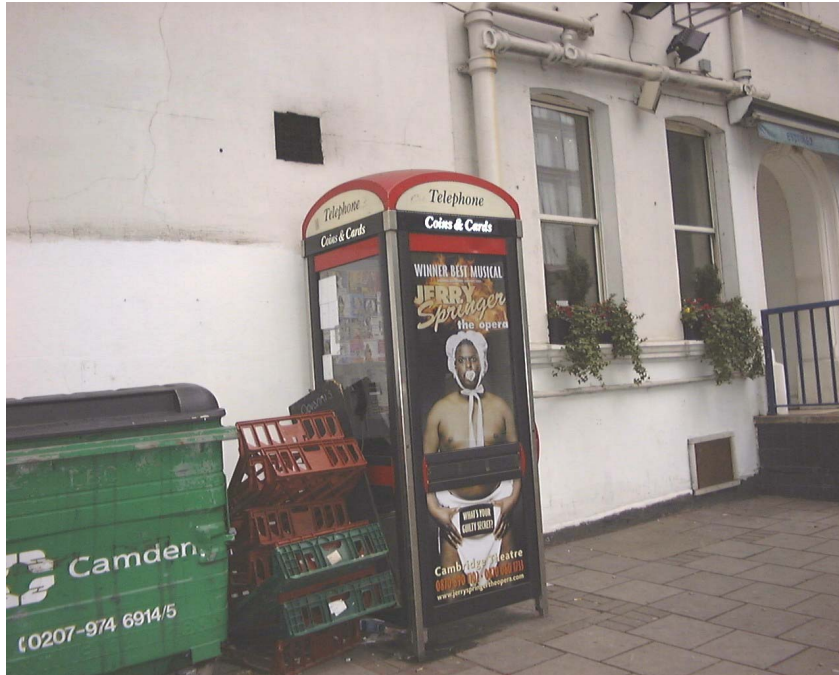
- When first visited, the view into the telephone box from the roadside was partly obscured by the advertisement on one side – the view now further obscured by bread baskets

- Signs of use by drug users (evidence included bandage with blood on)
- Display of cards inside advertising sexual services
- Used as a toilet
- The gap between the box and wall and the plant boxes provides potential hiding place for drugs

- Building to the right of photo is a coffee house – poor design features include:
  - Deep recessed doorway at top of steps has no grilles or shutters
  - Recess provides excellent view of immediate area for drug dealers as well as cover for drug abuse, rough sleepers etc.

- CCTV camera to left of building (not in photo) covers pavement area but not the recess or steps
  - Same man seen several times here during first visit who was most likely a drug dealer

- Very close proximity of underground station provides excellent escape route with beggars and rough sleepers also positioning themselves outside the station
